# TWA Flight 800

## The Devil is in the Details

by Robert W Allardyce & Captain Howard Mann (TWA, retired)

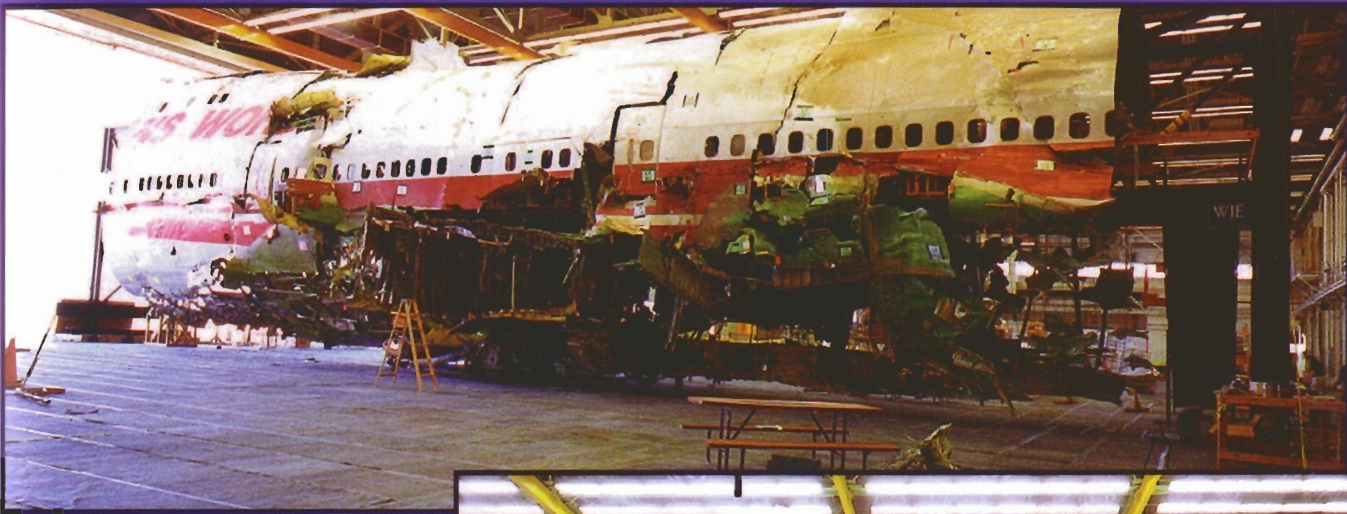
TWA 800 fuselage reconstruction. A photograph taken by the NTSB of the left side of the fuselage. The site of the breach was roughly abeam the L2 door.

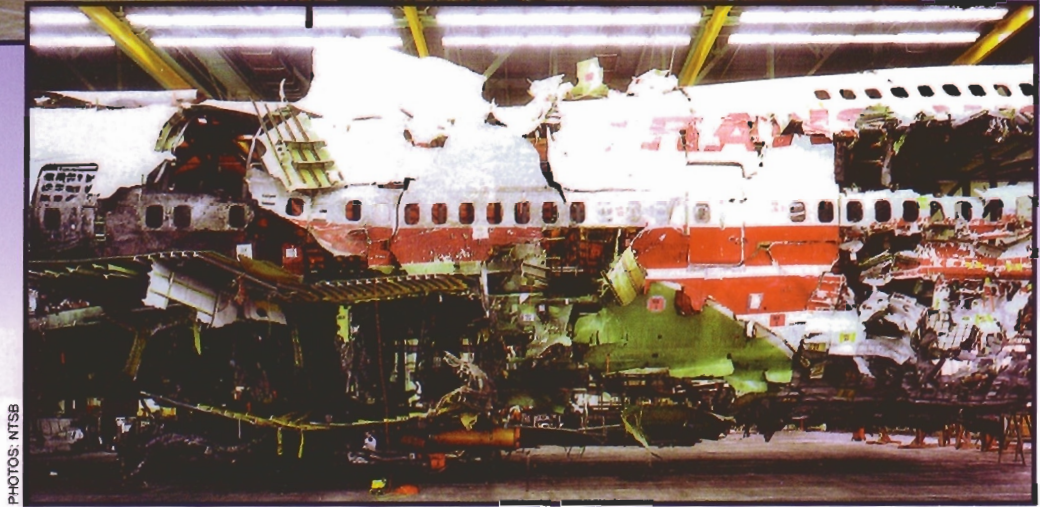
Original fuselage reconstruction. Another NTSB photograph shows that, unlike the left side, the skin of the right side of the forward section is splayed outward (that is from left to right). This is the result of a linear rather than an expanding omni-directional force emanating from the opposite side of the airframe.

complicated mathematical calculations and was able to triangulate the epicenter of the blast. Accordingly, Donaldson placed the epicenter near the "Low[er] left side [of the fuselage]...abeam aircraft station 576." Donaldson adds: "9 feet [2.74m] below the aircraft belly line [and] 17 feet [5.18m] from closest aircraft hull" (left). An NTSB diagram depicts the L2 door, located nearly abeam the epicenter of the explosion, having been blown loose and expelled from left to right. The opposite would have been true had the explosive pressure emanated from the CWT.
