TWA Flight 800 Analysis, by Steven J. Smith

TWA flight 800 overview:

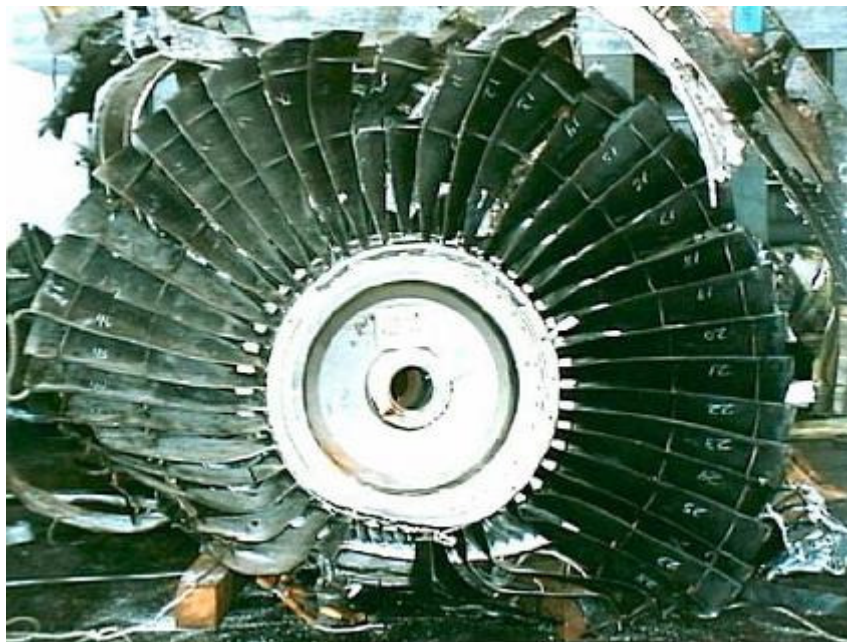
The photo on the right shows TWA 800 Engine No. 2 fan hub and blades. The blades are made from an alloy of 90% Titanium, 5.6% Aluminum, 4.2% Vanadium, and 0.2% Iron. Because this alloy is both very strong, and extremely brittle, the blades are cast in their final shape to minimize the amount of machining required. Under normal conditions, they will break rather than bend. Yet as the photo clearly shows, many of the blades are bent, some by as much as 90 degrees.

Furthermore, the TWA 800 photo is intentionally posed in such a manner as to imply the blades were bent by the weight of the hub/blade assembly, thereby removing any remaining doubt of complicity on the part of the NTSB. The NTSB while creating the

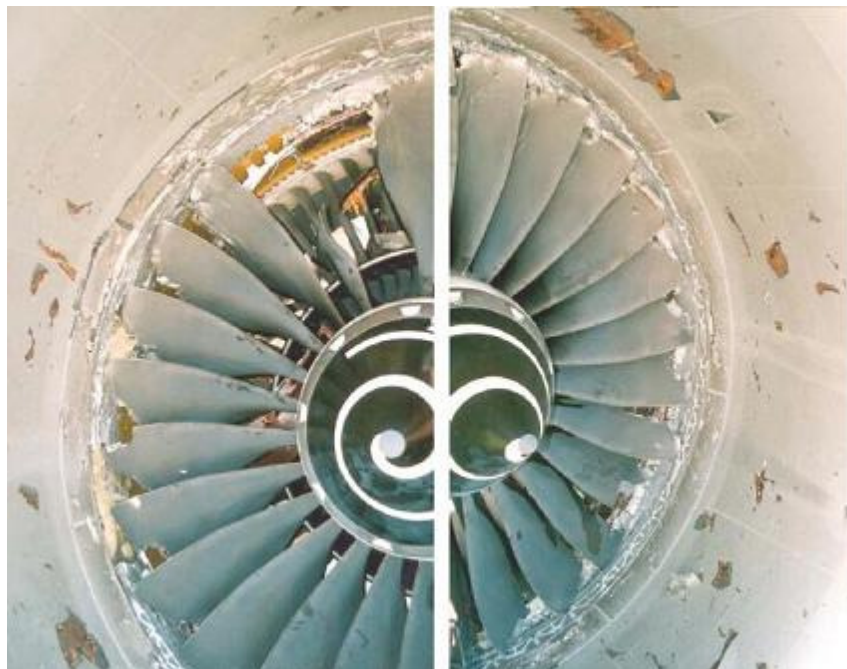
The photo on the right shows two views of a typical fan blade failure. In this case, one of the blades suffered progressive fatigue cracking at the root where it connects to the fan hub. The failure occurred on January 31, 2001 on a Boeing 777-300 at Melbourne International Airport, during the take-off run, and the flight was safely aborted. Notice how many of the remaining blades are missing portions of their tips, and one blade (adjacent to the missing blade) broke off at it's mid-section. However, none of the blades show ANY sign of bending, even though this engine (unlike TWA 800) was operating at full take-off power when the failure occurred. Clearly, something very odd AND very extreme took place in the final moments of TWA flight 800.

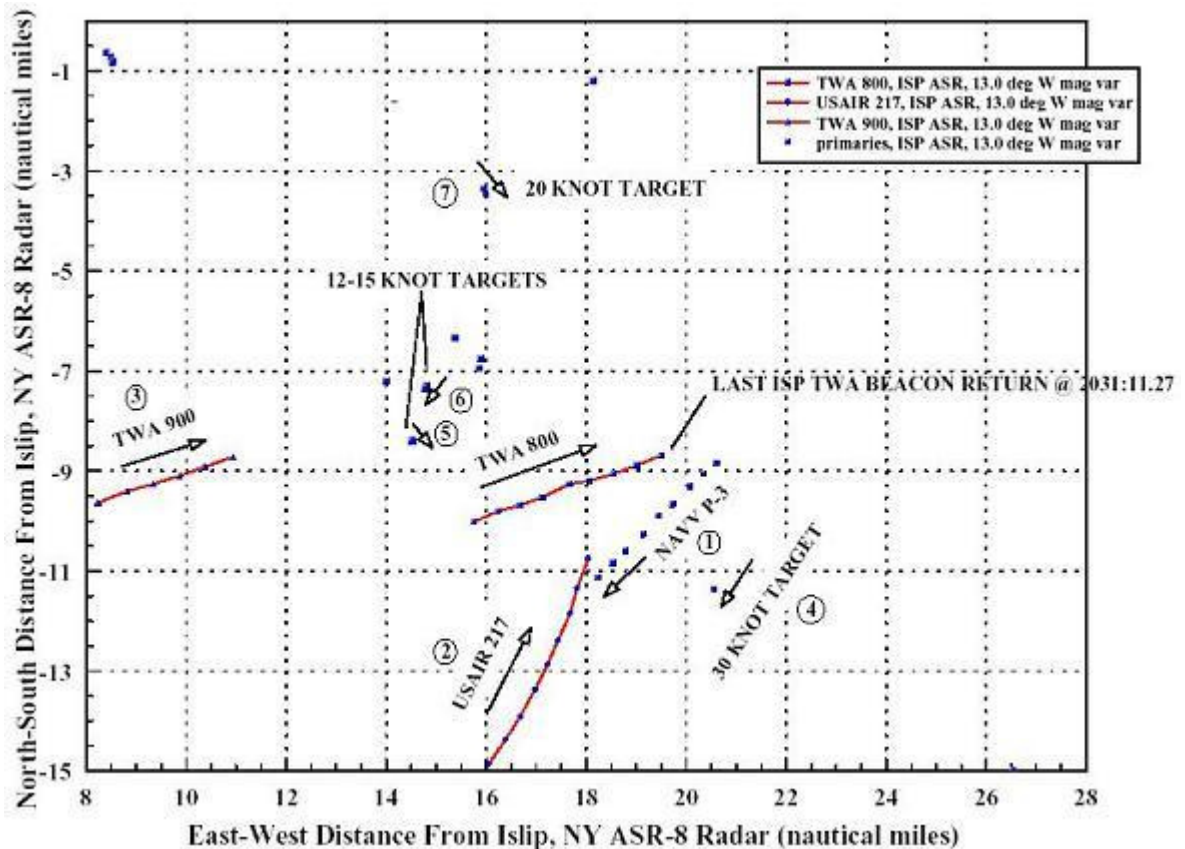
Part of exhibit 13A. Plot Courtesy of NTSB

The plot on the right shows radar data (the blue dots), obtained by the NTSB from the Islip radar station on Long Island NY. Each dot shows the position of an aircraft as the radar beam swept over the aircraft (the solitary, and closely spaced dots are slow moving water craft). For instance, dot 3 in each series is the position of that aircraft on the third sweep of the radar beam.

The plot shows the last 9 radar sweeps, before the destruction of TWA 800.

Notice the aircraft labeled "Navy P-3" moving southwest. This is an anti-submarine patrol craft, equipped with highly advanced electronic surveillance

systems. The aircraft would make an ideal observation platform to record the results of a covert particle beam weapon test. The P-3 is also a very robust aircraft (a variant is used for hurricane hunting), likely to survive even if it gets a bit too close to the target aircraft (TWA 800).

Coincidentally, the P-3 was flying at an altitude of just over 19 thousand feet, approximately the same altitude as TWA 800 was originally instructed to climb and maintain, before amendment by Boston air traffic control (see above). Obviously someone was worried about the surveillance aircraft being a bit too close to the test. According to the navy, this aircraft was on a "routine training mission"...
