# TWA Flight 800

## The Devil is in the Details

by Robert W Allardyce & Captain Howard Mann (TWA, retired)

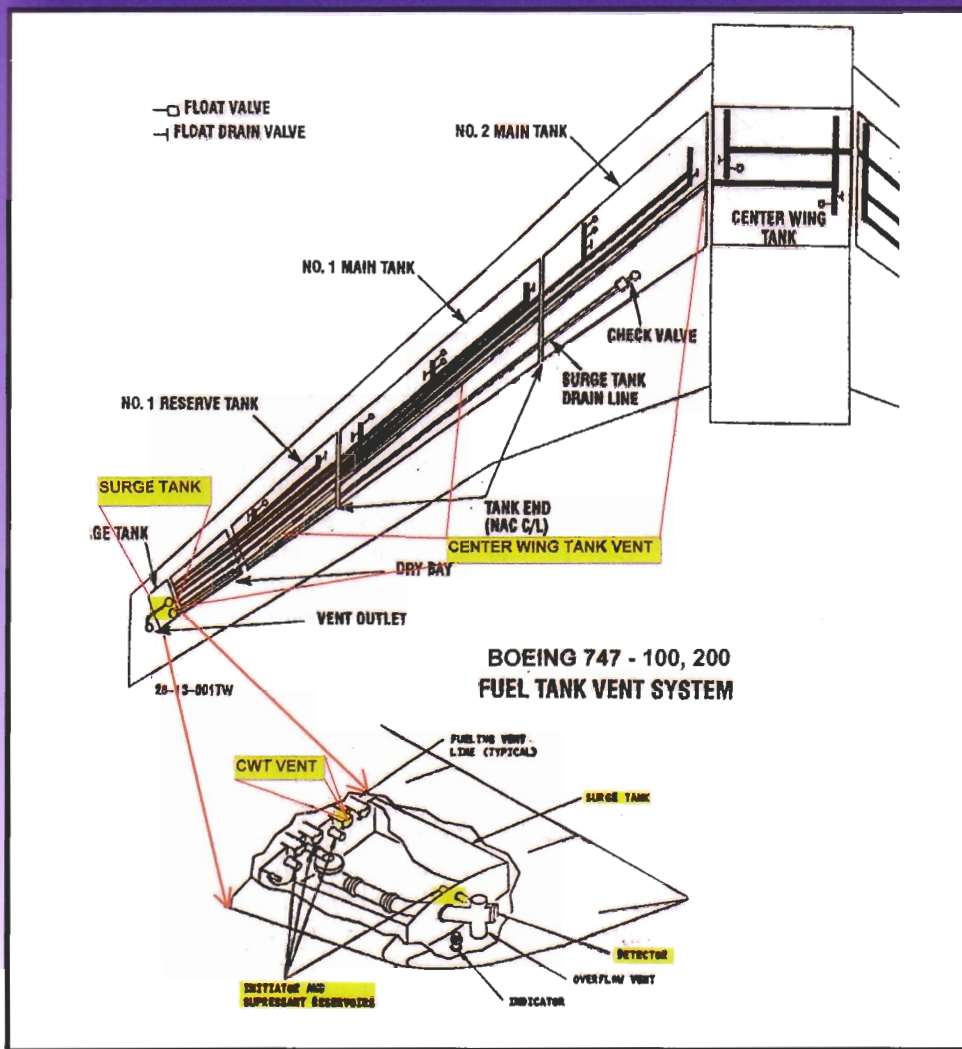
Clearly, neither of the two STP photoelectric sensors detected the presence of fire. So, the question is: Why didn't the photoelectric sensors react?

Highlighted in yellow, the photoelectric sensor was mounted on the outboard wall of each surge tank opposite the open end of the CWT's tank vent. Had a flame-front emerged from the CWT's tank vent, that photoelectric sensor was positioned to detect it and, within nanoseconds, flood the surge tank with inerting gas. Here is what the NTSB offered: "Although details of fire and soot documentation were performed by the Fire/Explosion Group, general observations of fire damage (or lack thereof) to the airplane systems were

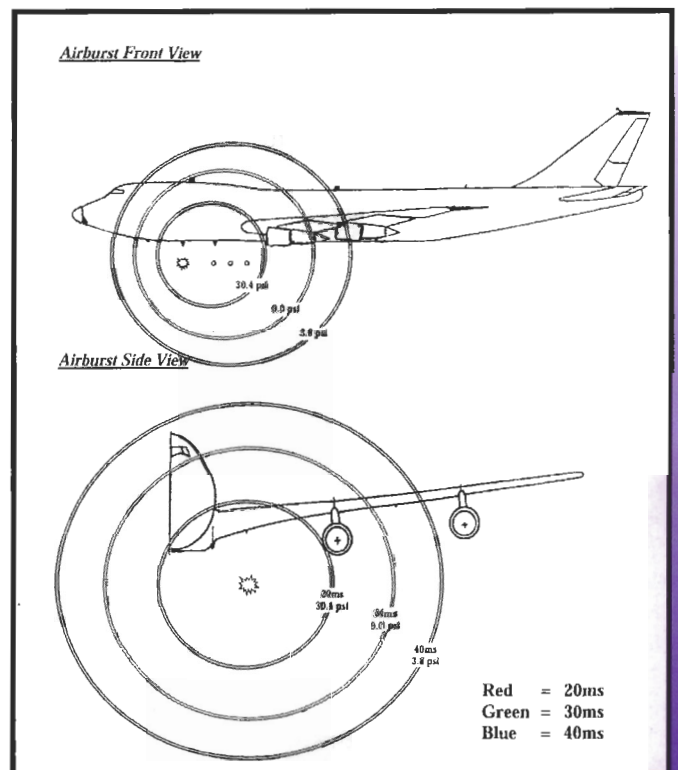
TWA 800 fuselage reconstruction. A photograph taken by the NTSB of the left side of the fuselage. The site of the breach was roughly abeam the L2 door.

complicated mathematical calculations and was able to triangulate the epicenter of the blast. Accordingly, Donaldson placed the epicenter near the "Low[er] left side [of the fuselage]...abeam aircraft station 576." Donaldson adds: "9 feet [2.74m] below the aircraft belly line [and] 17 feet [5.18m] from closest aircraft hull" (left). An NTSB diagram depicts the L2 door, located nearly abeam the epicenter of the explosion, having been blown loose and expelled from left to right. The opposite would have been true had the explosive pressure emanated from the CWT.
